***Report No. UT-03.34***

***FLEXURAL PERFORMANCE OF  
RETROFITTED REINFORCED  
CONCRETE CANTILEVERED  
BENT CAPS – PART 2***

**Utah Department of Transportation  
Research Division**

**December 2003**

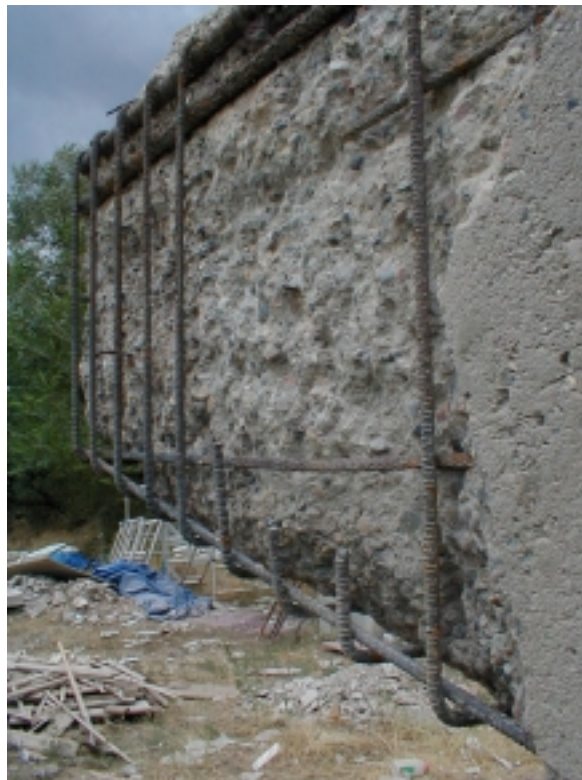
Figure 2.36 – Bent 13S after concrete was chipped away

Figures 2.29-2.31 show the bent after removing unsound concrete. There was a significant amount of reinforcement exposed on the East side of the bent with many of them considerably corroded. Figure 2.32 shows the amount of exposed reinforcement corrosion in the bent. The numbering shown represents the approximate percentage of remaining area. There were three vertical and one horizontal bars that were completely corroded (these bars are represented in Figure 2.32 by 0% rebar remaining). These bars were removed as shown in Figure 2.36 and not replaced.

As with the other bents, the first step in repairing Bent 13S was to chip away the concrete around the exposed rebar. As can be seen in Figures 2.33, careful consideration was taken to fully expose the reinforcement by chipping away approximately 1.5 inches (38 mm) of concrete around it. Figures 2.34-2.36 show the condition of the bent after the concrete was completely chipped away.

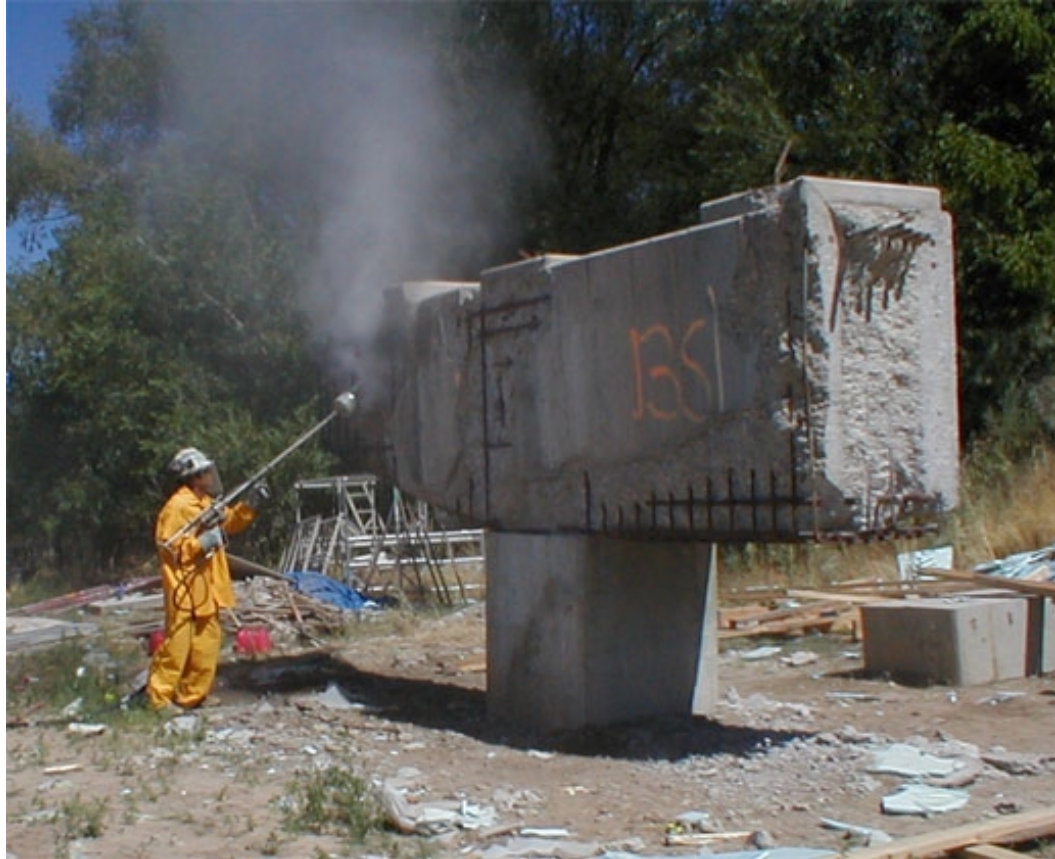
Figure 2.37 – Hydro jetting of Bent 13S

After the sections of rebar were fully exposed, the bent was cleaned by hydro-jetting. Figure 2.37 shows Bent 13S being hydro jetted. Hydro-jetting is the shooting of water at high pressure (approximately 25-35 ksi (173-242 MPa)), and performs various functions. First, it removes the unwanted rust from the rebar so that a good bond can be developed between the new concrete and the rebar. Second, hydro jetting knocks away any loose concrete and creates a rough surface so the old and new concretes can bond better. Figure 2.38 shows an untreated surface (bottom portion of the picture) and a treated surface (top portion of the picture).

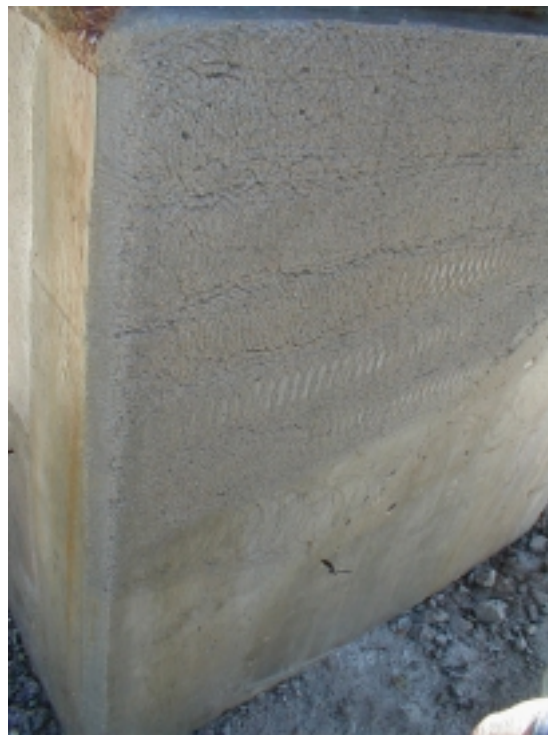
Figure 2.38 – Concrete surface; upper portion: hydro-jetted, bottom portion: normal

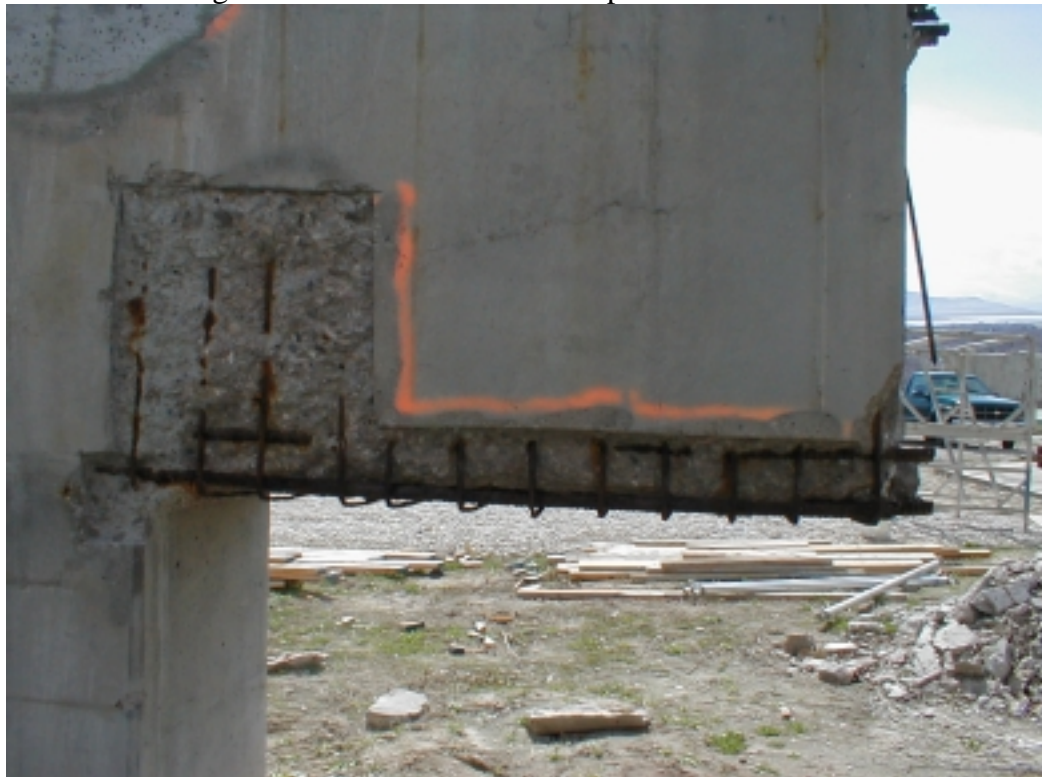
Figure 2.50 – West face of 13N

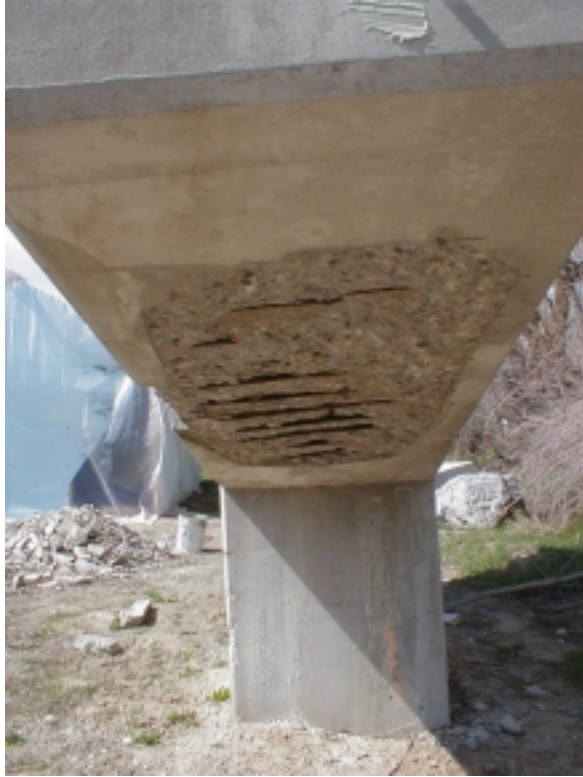
Figure 2.51 – Bottom of the cantilever of 13N

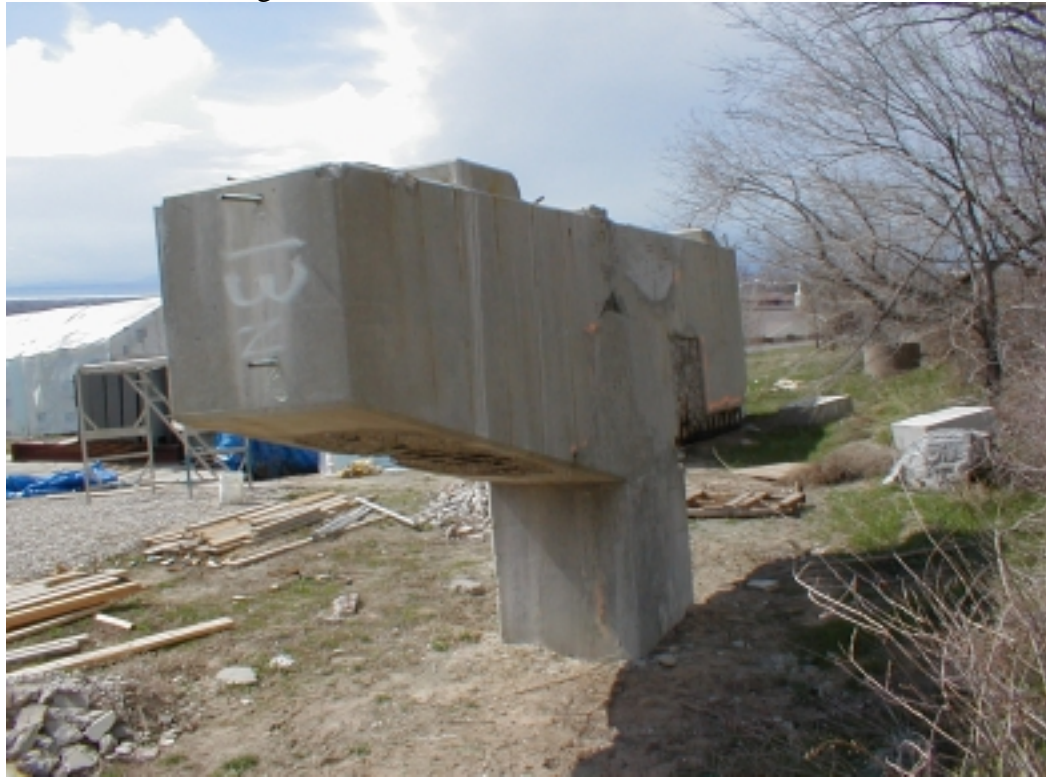
Figure 2.52 – Overall West face of Bent 13N

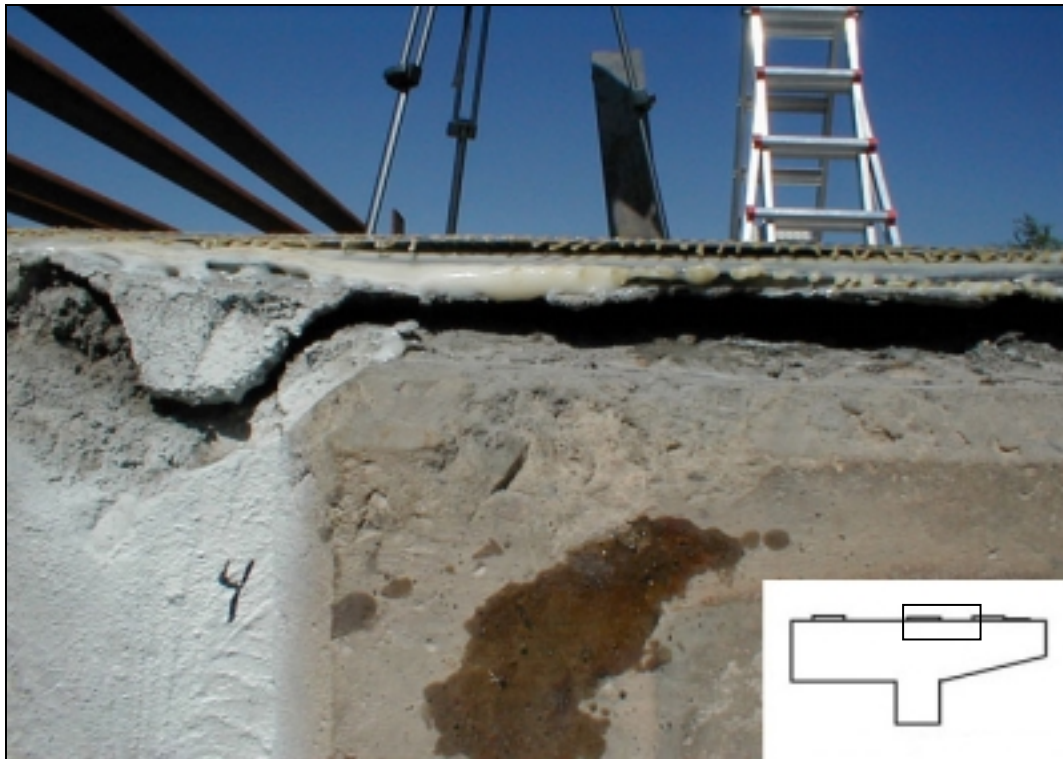
Figure 4.89 – Bent 13S, close up of the debonded region

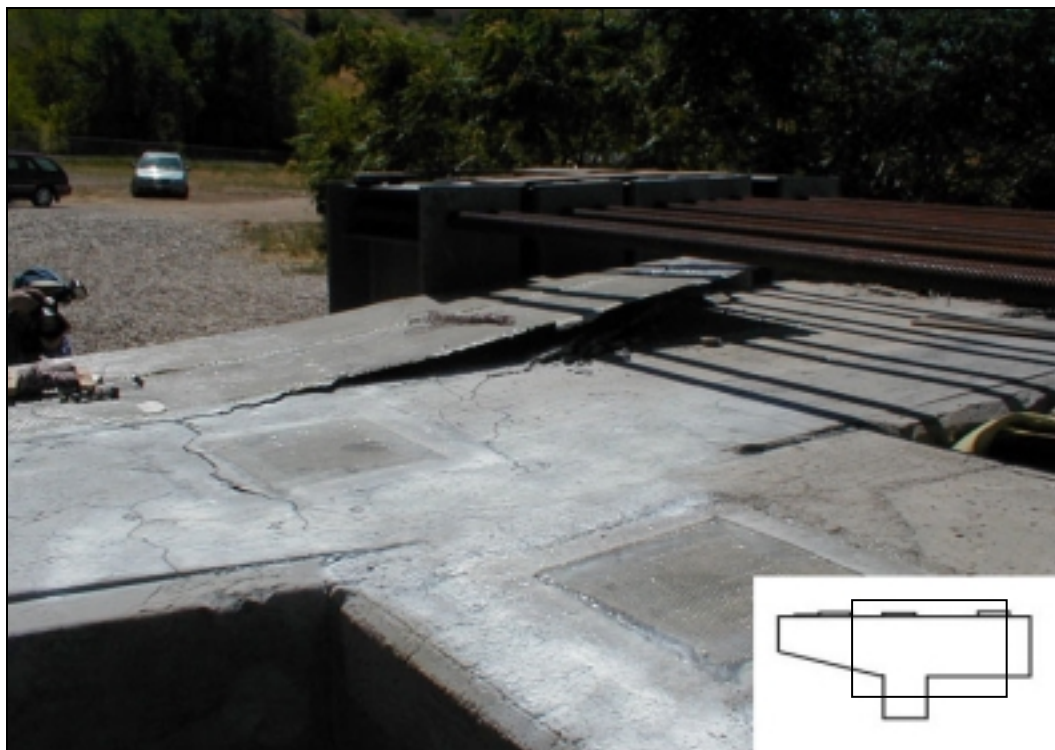
Figure 4.91 – Ben13S, debonding of wrap—overall view

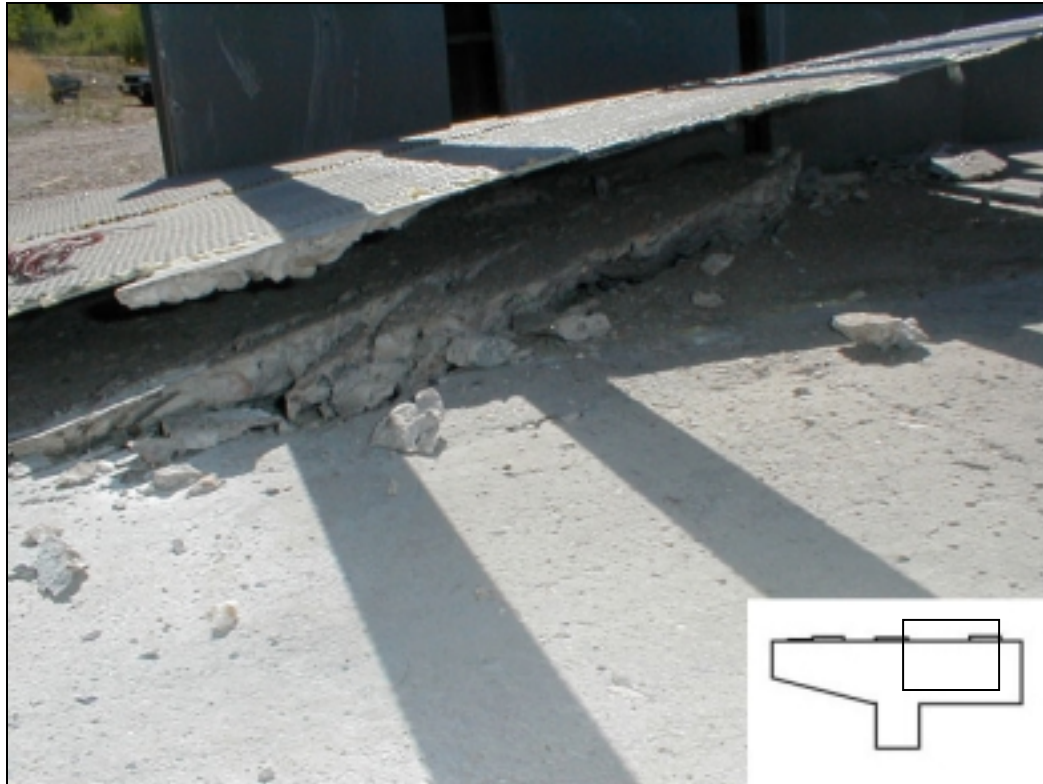
Figure 4.92 – Bent 13S, close up of debonded region

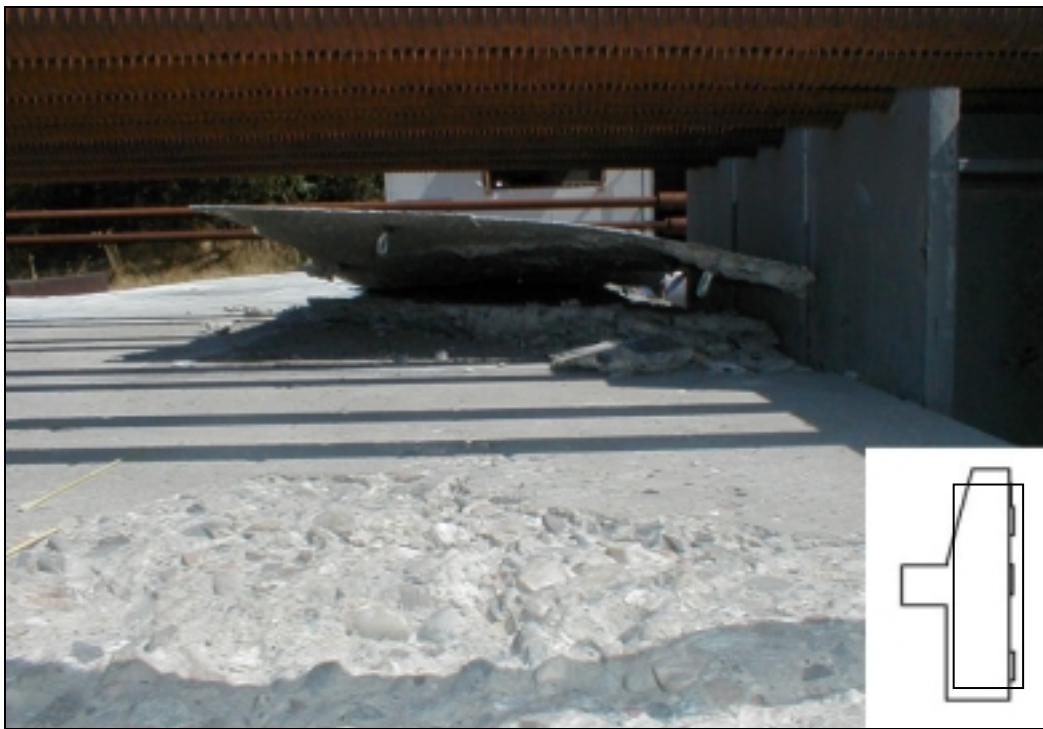
Figure 4.93 – Bent 13S, complete failure of CFRP

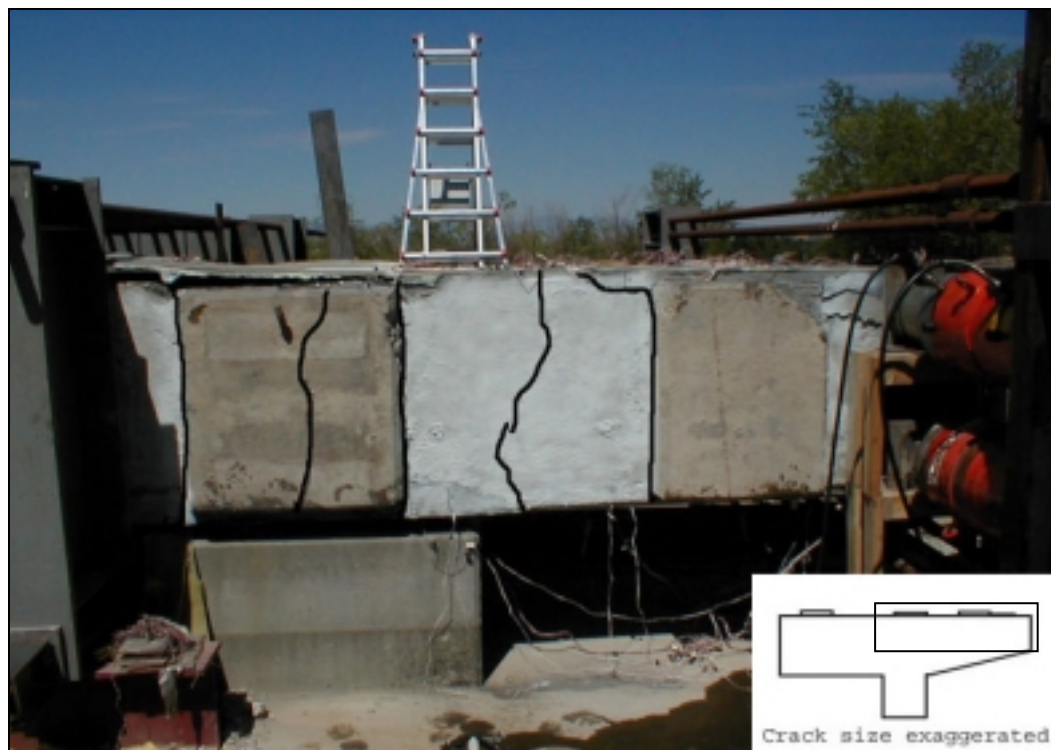
CFRP completely debonded. The cracks in the cross section of the bent lengthened significantly and two new cracks formed. These new cracks are the two cracks on the right most side of Figure 4.94. Figure 4.95 shows a new crack that developed on the top of the bent in the middle of the middle pedestal. Figure 4.96 shows that the debonding went as far as the right side of the middle pedestal. The crack width at the bottom of the reentrant corner on the middle pedestal was about 0.375 in (9.5 mm) as shown in Figure 4.97. After the debonding occurred the testing was stopped so as to prevent any possible damage to the instrumentation. Even though the bent could probably sustain more loading cycles, after the failure of the CFRP, the bent would be expected to behave in a similar manner to the other concrete patched bents and not be able to carry a greater load than the ultimate load of 762 kips (3390 kN). Unlike the compression zone of the other bents, the concrete in the compression zone of Bent 13S did not crush as shown in Figure 4.98.

Figure 4.95 – Bent 13S, new cracks in the middle of the pedestal

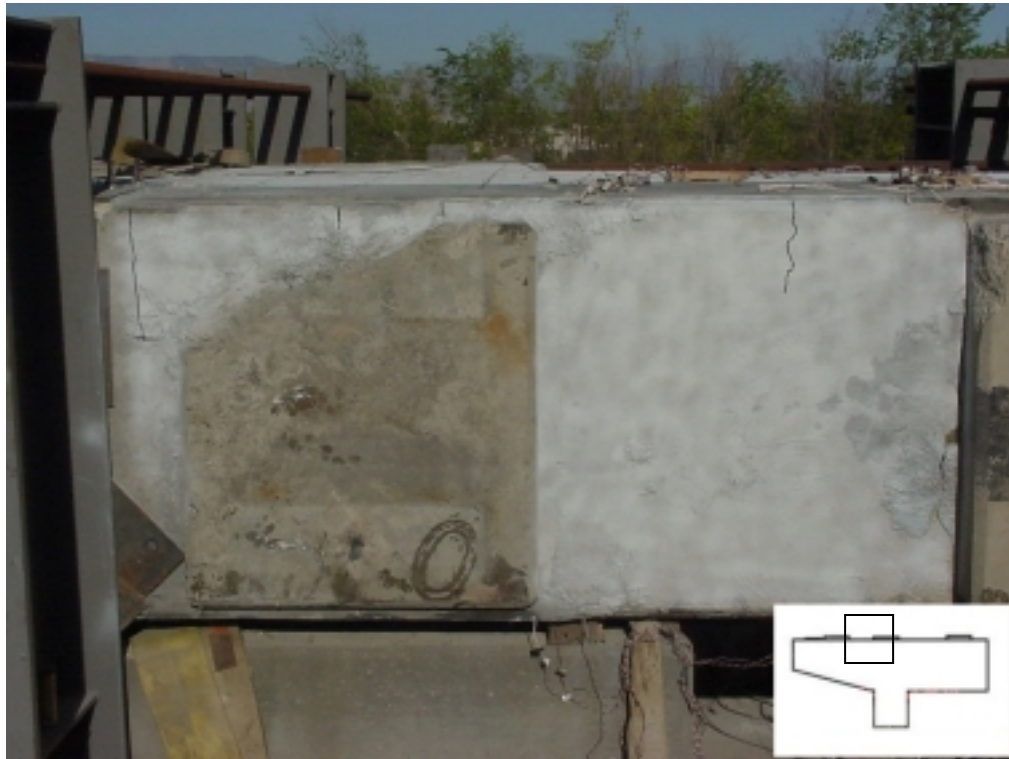
Figures 4.101 and 4.102 show shrinkage cracks on bent 13N. These cracks were marked to distinguish between existing and new cracks. In the opinion of the authors, the existence of these cracks did not influence the response of the bent. Figure 4.103 shows the condition of the bent after the third loading cycle. Small cracks started to appear on the top of the bent. No new cracks were visible on the side of the bent after the third loading cycle.

Figure 4.102 – Bent 13N, shrinkage cracking, top

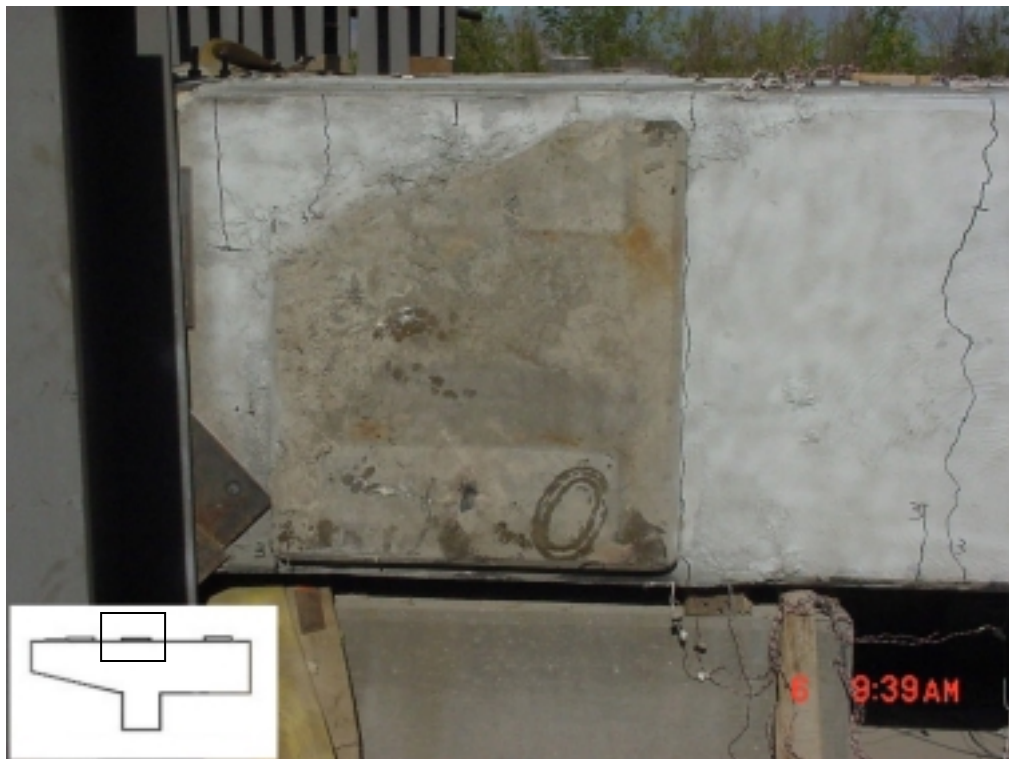
Figure 4.103 – Bent 13N, cracks after cycle 3

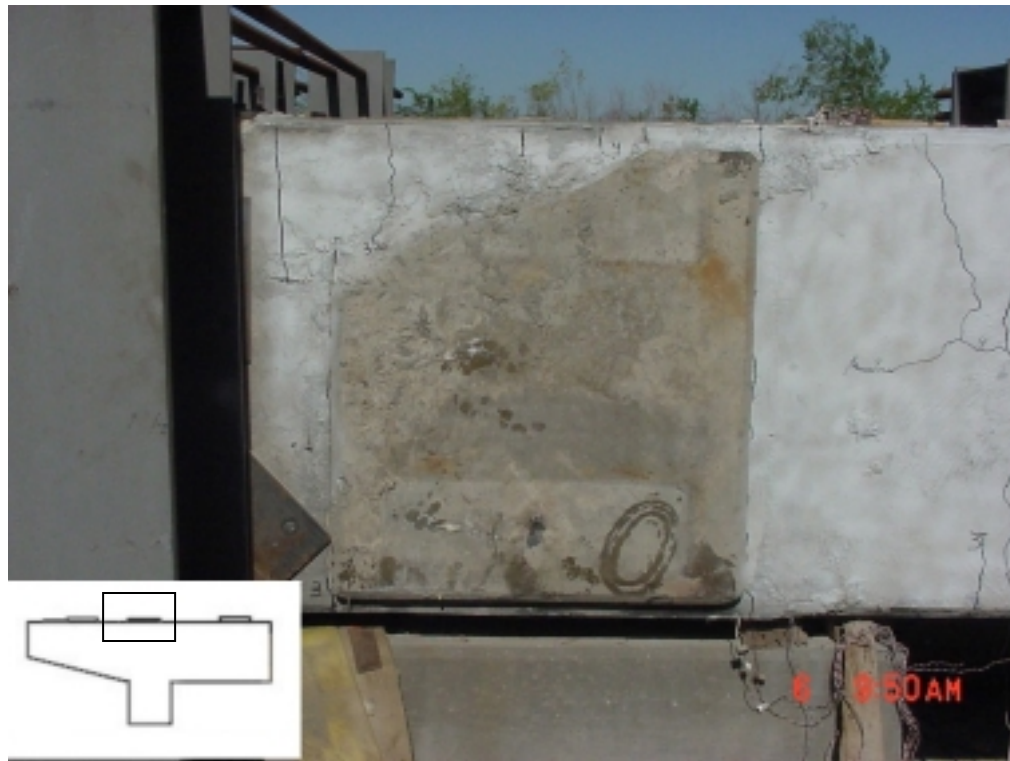
On the fourth cycle a new vertical and a new horizontal crack formed on the top of the bent. These cracks are shown in the right side of Figure 4.104. The vertical crack similar to previously observed vertical cracks is due to bending. The horizontal crack may be due to localized bond failure along the flexural reinforcement. The propagation of this horizontal crack may be an indication of bond failure. The cracks that were visible after the third cycle became slightly widened after the fourth cycle.

Figure 4.104 – Bent 13N, cracks after cycle 4

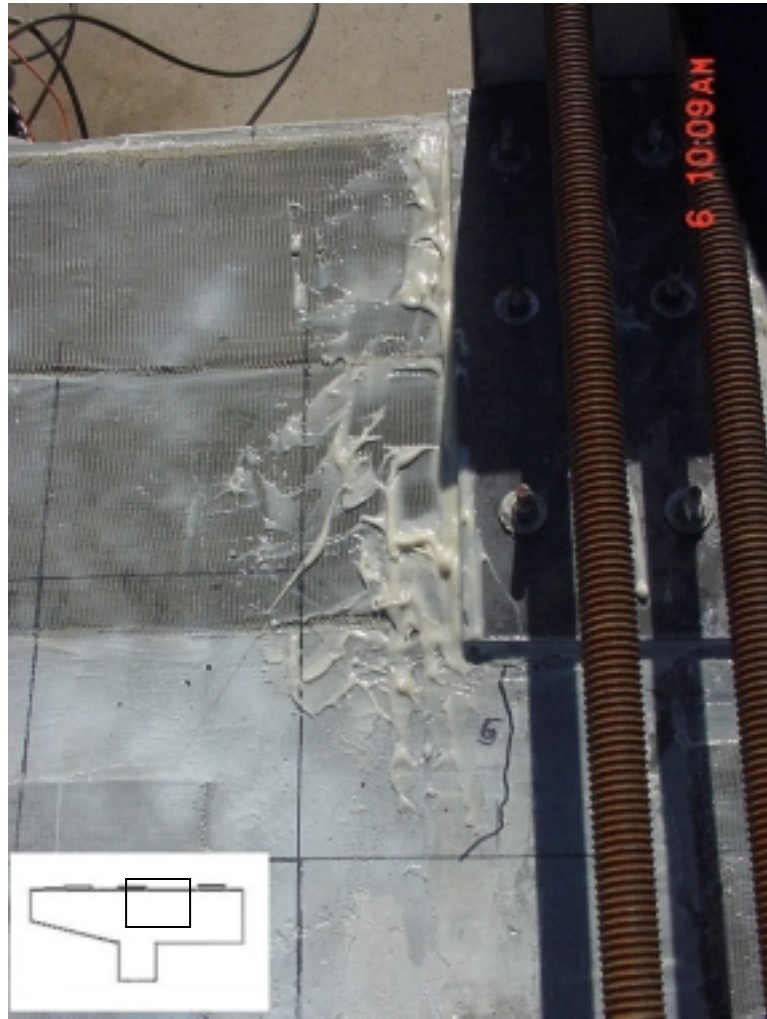
On the fifth cycle at a peak load of 501 kips (2229 kN) and deflection of 0.22 in (5.6 mm), one crack appeared at the end of the FRP wraps (Figure 4.105). The authors believe this is the same crack that appeared near the beginning of the anchoring steel system (Figure 4.106). Because the crack is under the FRP wrap, its path could not be determined exactly. Three new cracks also appeared on the face of the bent (Figure 4.107). The exactly path of these cracks toward the top of the bent could not be traced since they were also covered by the FRP wrap. New cracks also appeared on the top of

Figure 4.106 – Bent 13N, crack around FRP wrap and steel plates after cycle 5

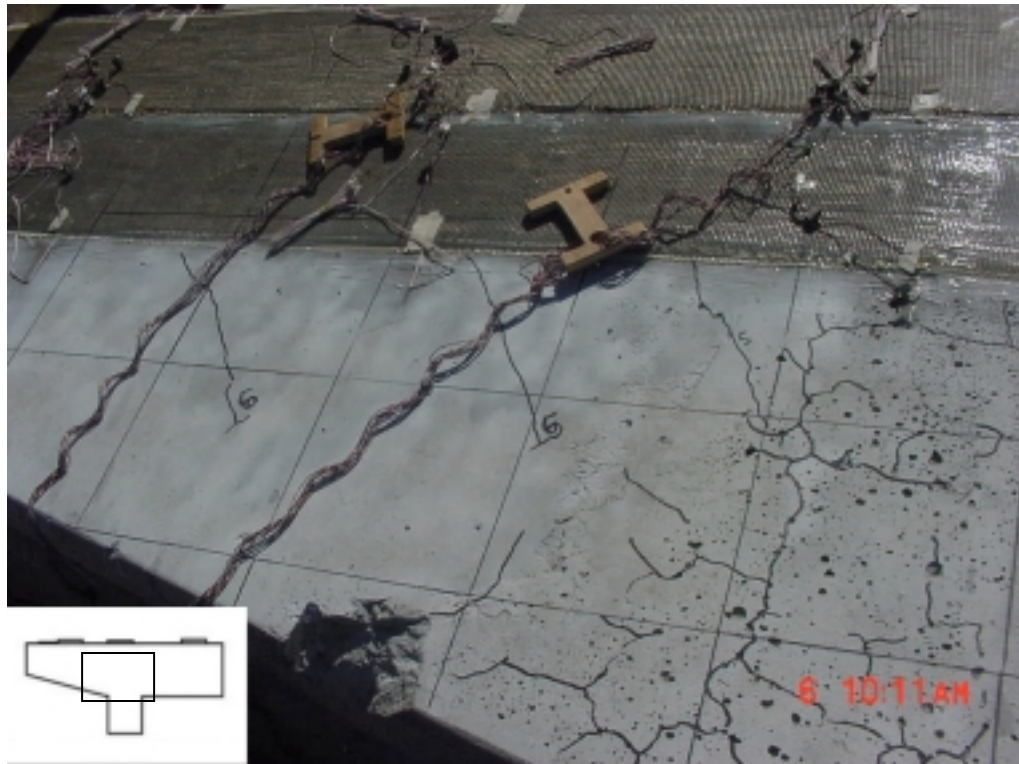
Figure 4.107 – Bent 13N, cracks on the face of the bent after cycle 5

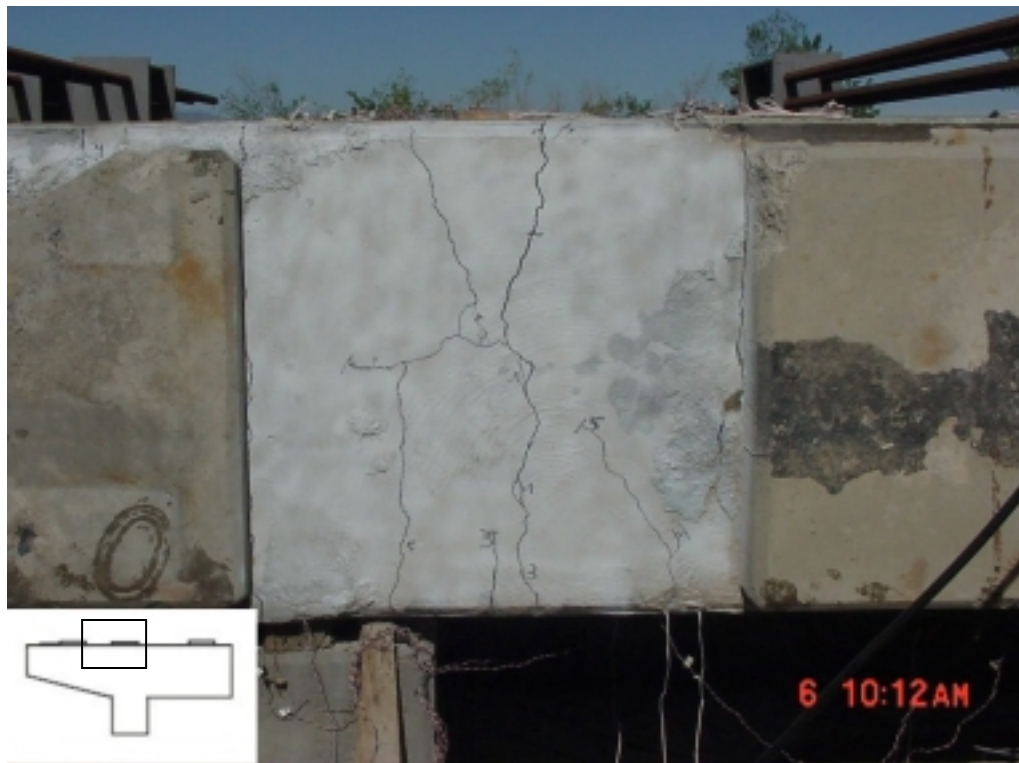
the bent (Figure 4.108). The horizontal crack that appeared at the end of the fourth cycle did no propagate any farther.

Figure 4.108 – Bent 13N, cracks on the top of bent after cycle 5

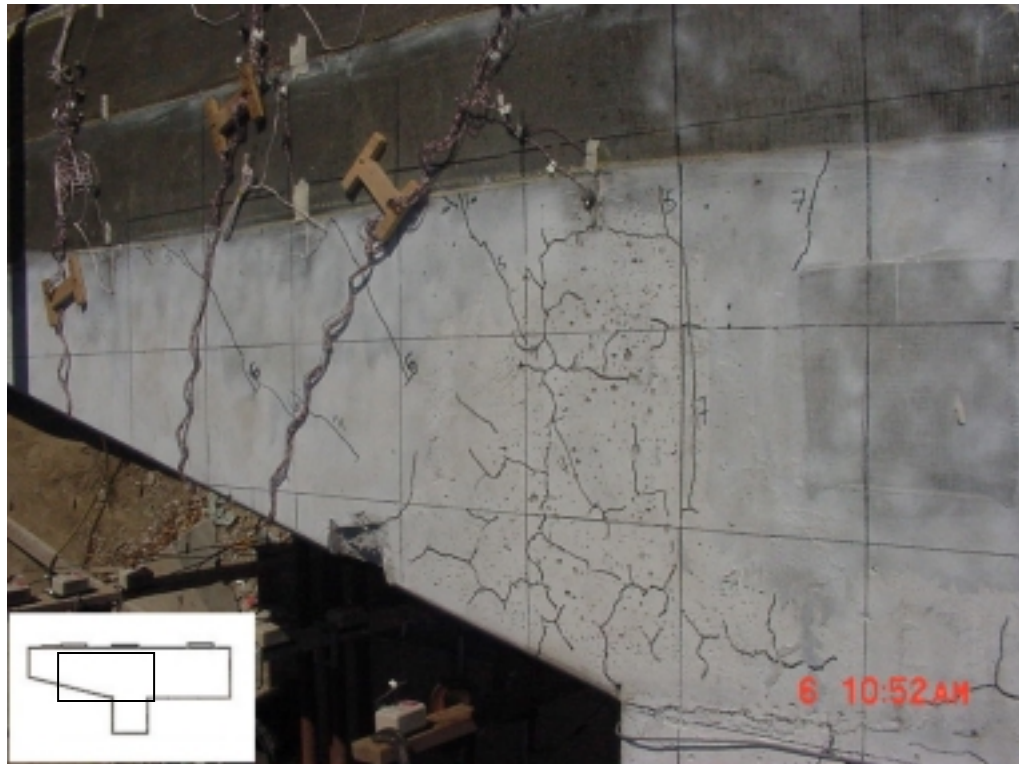
Figure 4.112 – Bent 13N, cracks on the face of the bent after cycle 7

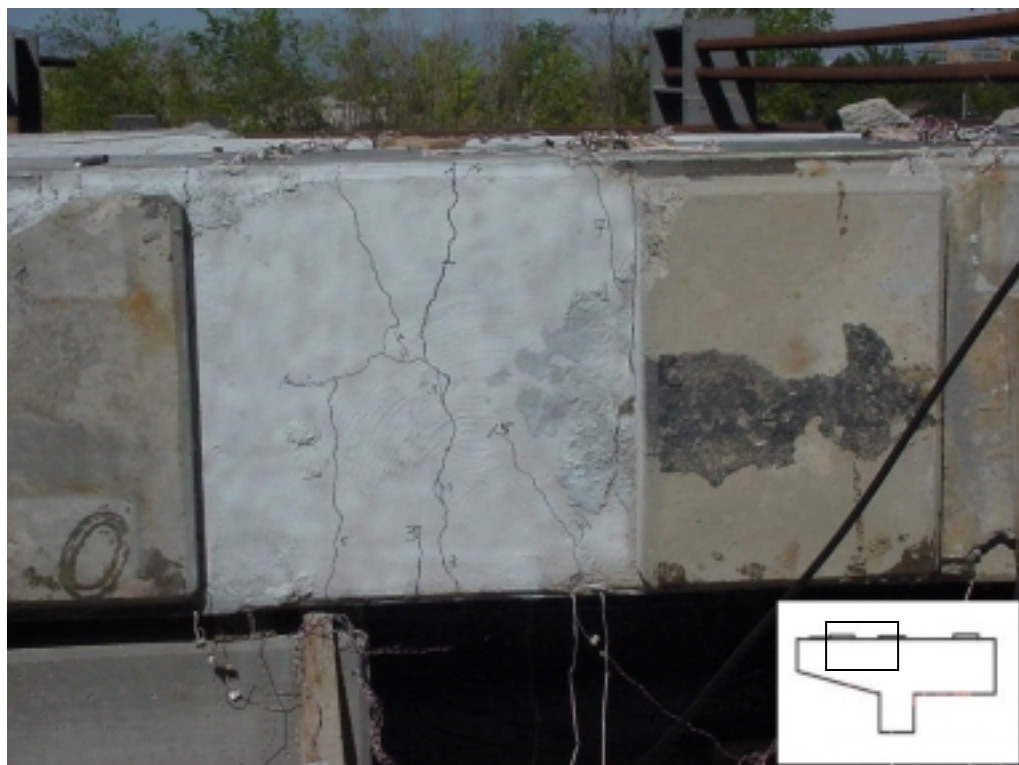
Figure 4.113 – Bent 13N, cracks on the top of bent after cycle 7

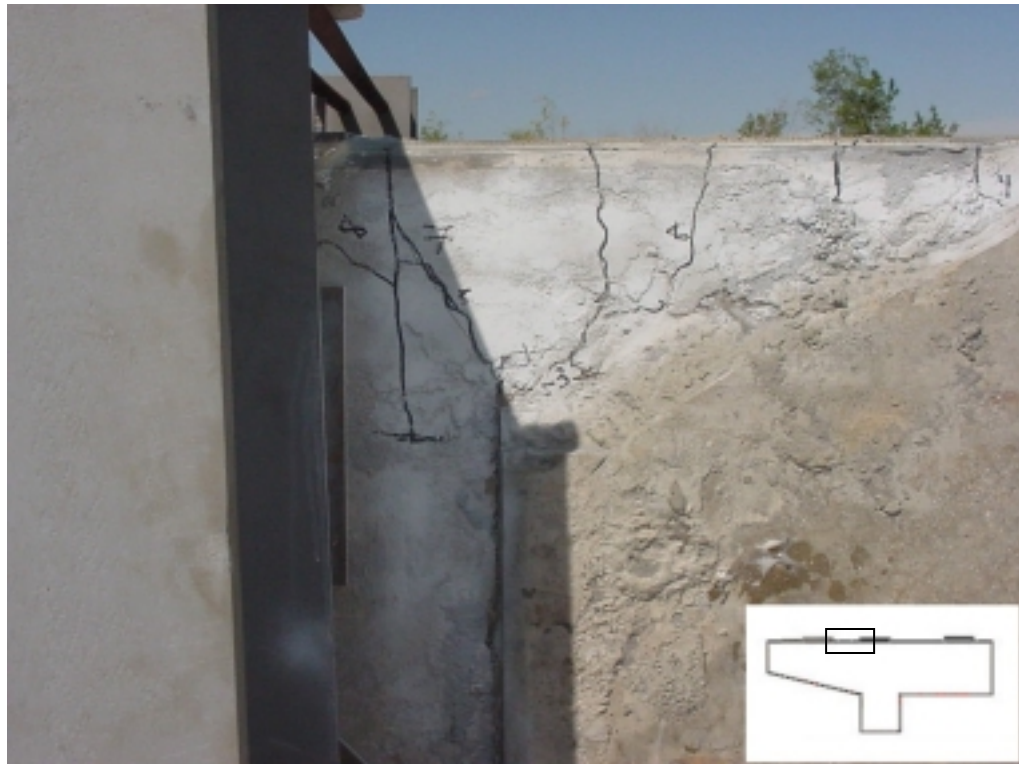
On the seventh cycle at a peak load of 761 kips (3386 kN) the crack at the end of the of the FRP wraps (Figures 4.105 and 4.109) connected to the crack near the beginning of the anchoring steel system (Figure 4.106) as shown in Figure 4.111. The FRP wrap started to debond at its ends (Figure 4.111). The cracks at the cantilever and the top of the bent widened. Two new cracks appeared: one on the cantilever (Figure 4.112) and one at the top (Figure 4.113). On the eighth cycle cracks became more visible because of widening (Figure 4.114) and because of propagation (Figure 4.115).

Figure 4.114 – Bent 13N, cracks on the top of bent after cycle 8

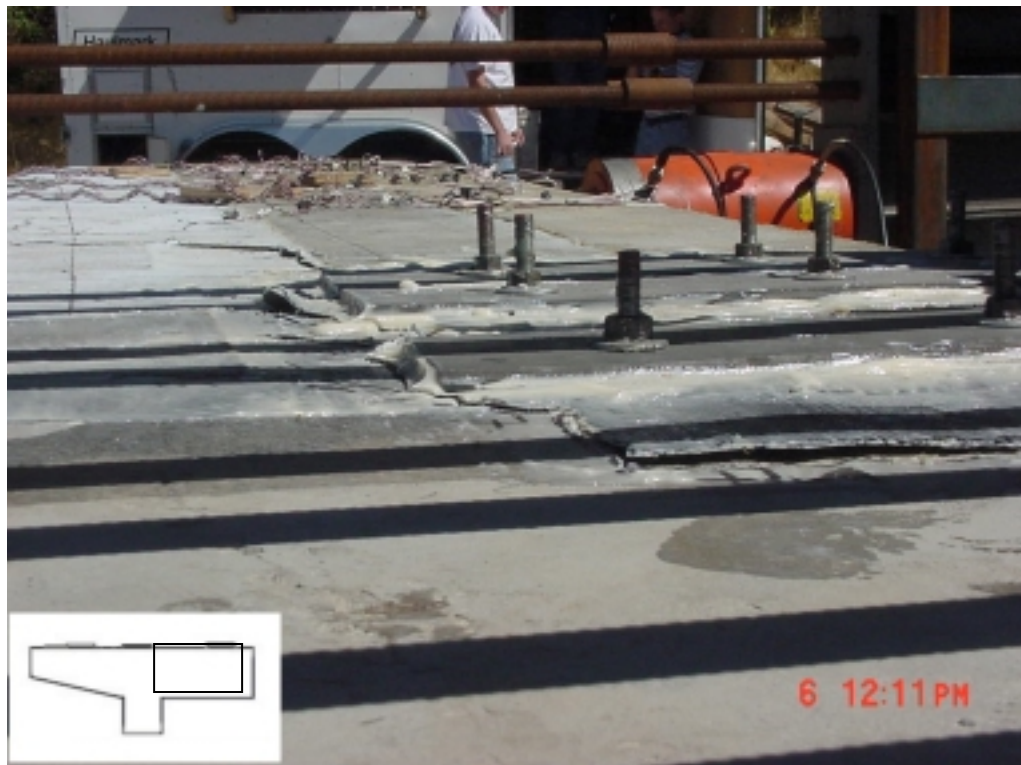
Cracks previously observed continued to lengthen and widen on the ninth cycle at a peak load of 873 kips (3885 kN). The crack on the top of the bent near the pedestal became very large (Figure 4.116) and the cracks on the face of the cantilever started to converge to the main compression zone near the intersection of the column and the cantilever (Figure 4.117). As seen in Figures 4.116 and 4.117 the cracks are well distributed along the tension side of the bent indicating that the bent is failing in flexure. As shown in Figures 4.118 and 4.119, the crack that started at the end of the FRP wrap continued around the steel anchoring system and propagated toward the main compression focus point. The steel anchoring system performed as intended and designed by keeping the ends of the FRP wraps anchored to the concrete even when the FRP wrap started to debond and significantly “pry up” as shown in Figures 4.119 and 4.120. If the anchoring system was not effective, the bent most likely would have failed already.

Figure 4.119 – Bent 13N, gap caused by the crack around FRP wrap and steel plates after cycle 9

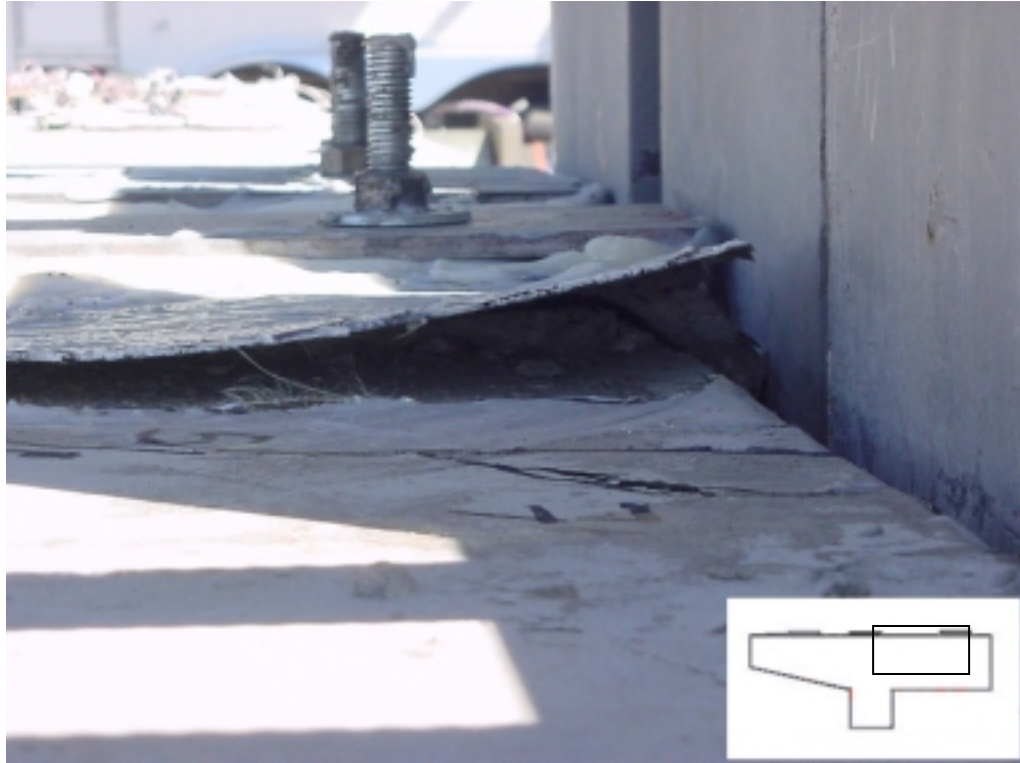
Figure 4.120 – Bent 13N, gap at the end of FRP wrap after cycle 9

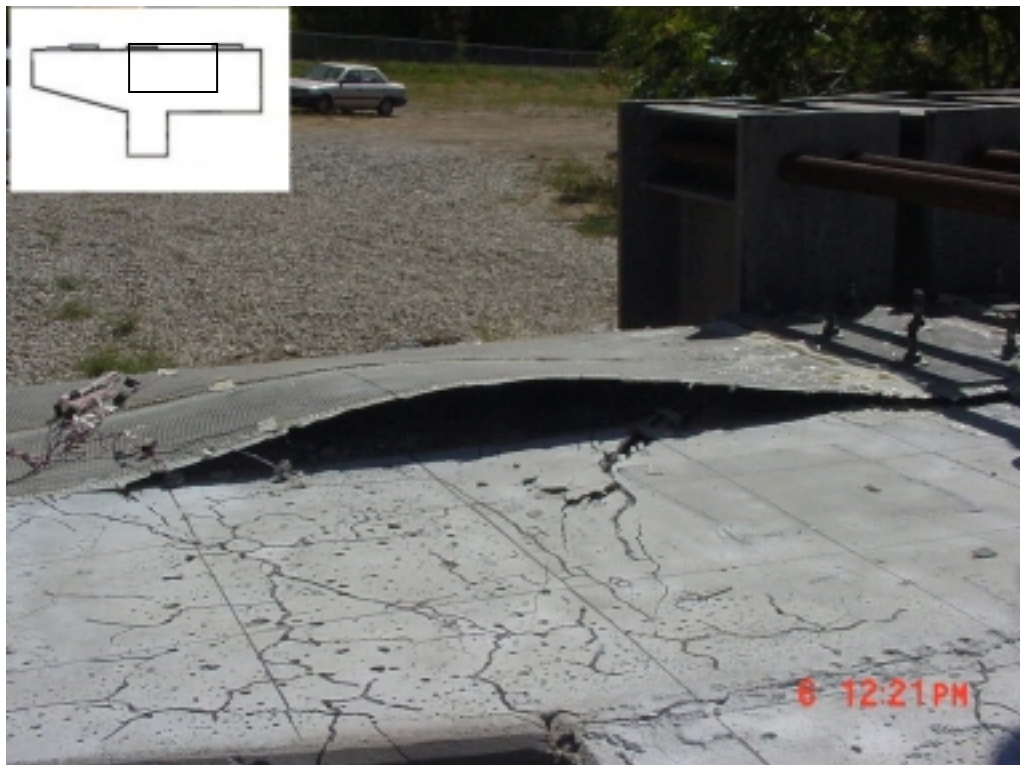
Cracks propagated and widened significantly during the tenth cycle at a peak load of 882 kips (3925 kN). Also, the FRP wrap debonded and buckled as shown in Figure 4.121. During this cycle only the anchoring bolts appear to be effective by transferring the load through shear from the FRP wraps to the concrete since the entire FRP wrap appears to have completely debonded (Figure 4.122). Cracks were very wide near the pedestal (Figures 4.123 and 4.124). Testing was halted after the tenth cycle to prevent

Figure 4.121 – Bent 13N, buckling of FRP wrap during cycle 10

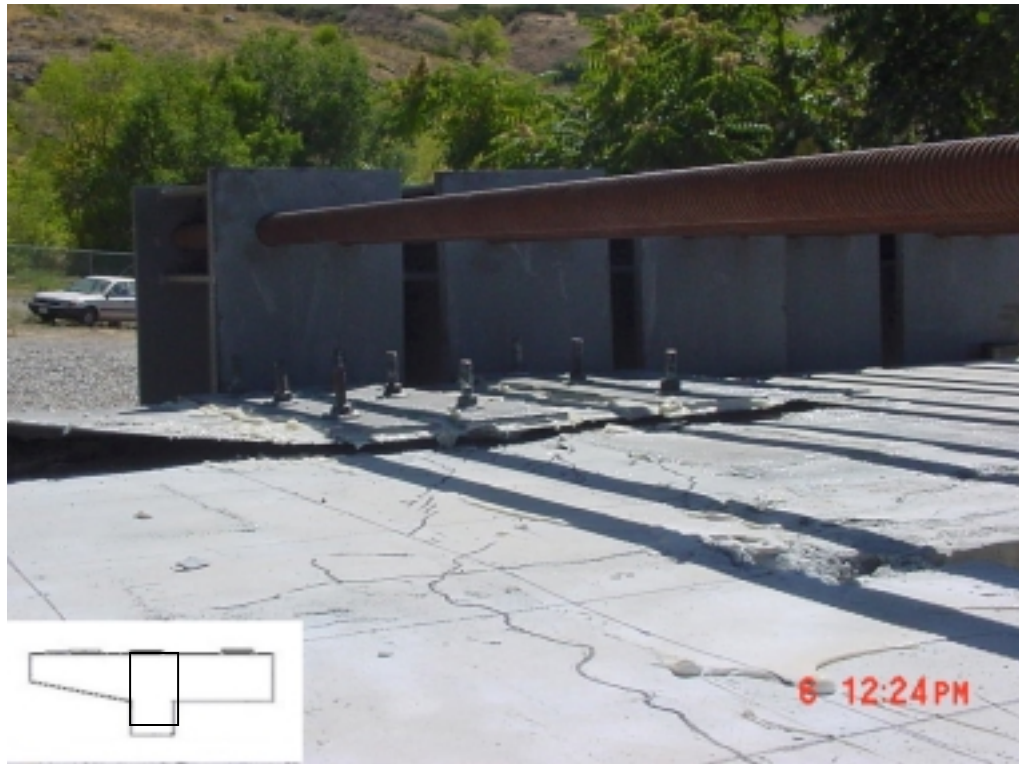
Figure 4.122 – Bent 13N, crack around FRP wrap and steel plates during cycle 10

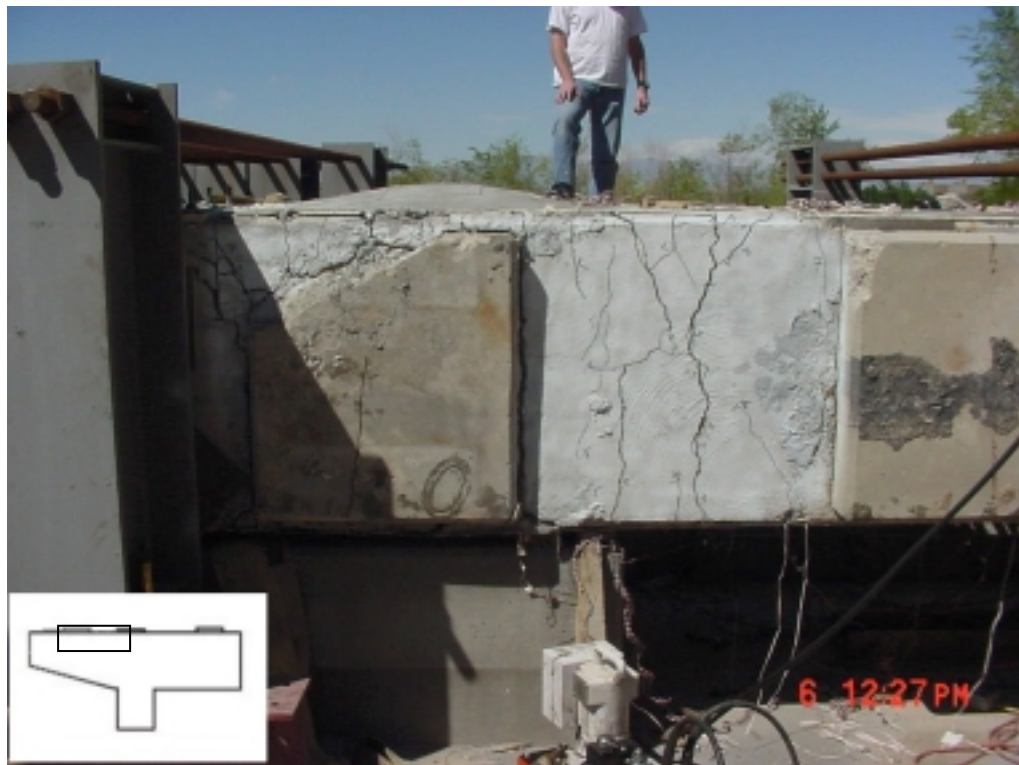
Figure 4.123 – Bent 13N, cracks on the top of bent after cycle 10

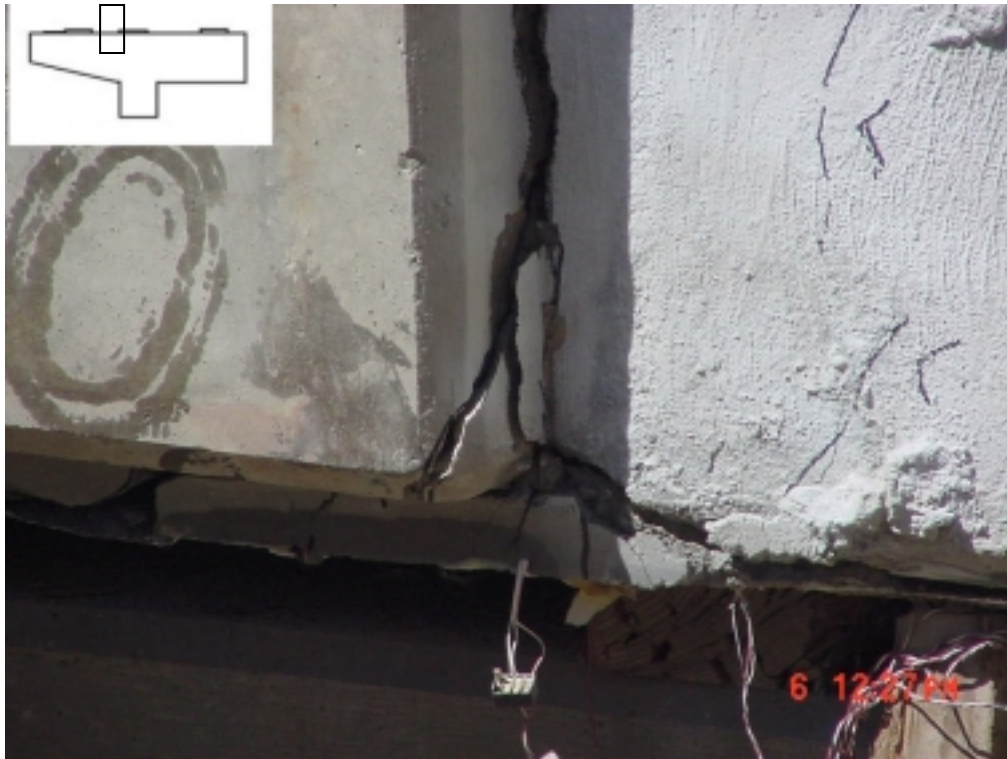
Figure 4.124 – Bent 13N, crack approximately 0.375 in (13 mm) wide after cycle 10

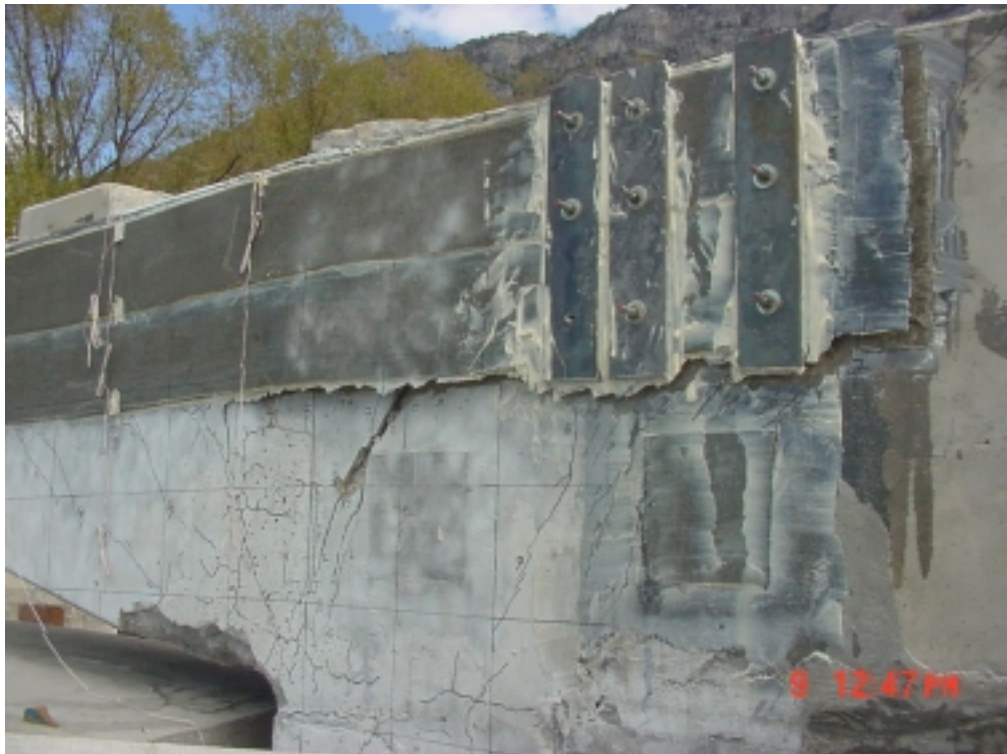
damage to the instrumentation. Figure 4.125 shows the condition of the FRP wrap after testing. An inspection of the steel anchoring system indicated that most of the steel bolts had sheared off (Figure 4.126).

Figure 4.125 – Bent 13N, condition of the bent after testing
